## TURNING OF ROLL BEARING STEEL 100CR6 OF BAINITE STRUCTURE

*Neslušan Miroslav, Department of Machining and Automation, University of Žilina, Univerzitná 8215/1 010 26, Slovak Republic*

**Abstract:** *This paper deals with turning of bainite roll bearing steel 100Cr6. There is presented significance of the correct heat treatment and its influence on the cutting process through the measurement of cutting forces and tool wear. The paper compares the results of turning of martensite and bainite structure.*

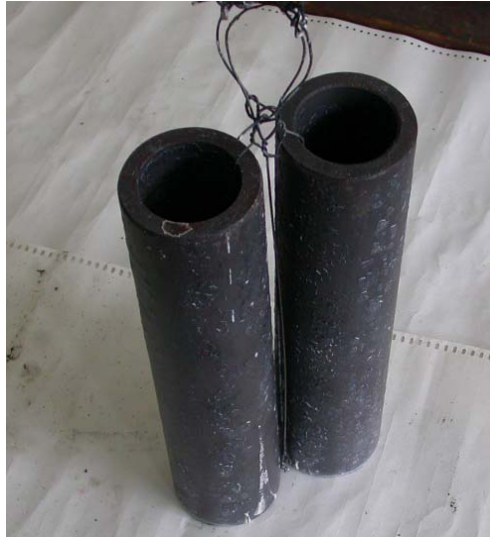
**Fig.2** Position of pieces during the heat treatment

Analyze of hardness shows that there is not the uniform cooling of the pieces settled according fig.2. In the place of the pieces contact, there is the higher concentration of heat and so the cooling process in this contact is slower. This slower cooling process affects structural changes during the heat treatment and lead to lower hardness (fig.3 b). The next, there is hardness changes not only from the point of view of the tube periphery, but from the point of its length. This is caused by the better conditions for heat transfer near by the end of the piece. There is no visible significant change of hardness at the end of the workpiece (fig.3 a). The higher mentioned hardness change caused by no uniform cooling should be related to the bainite transformation. There are no significant changes in hardness considering the martensite structure (fig. 4b).

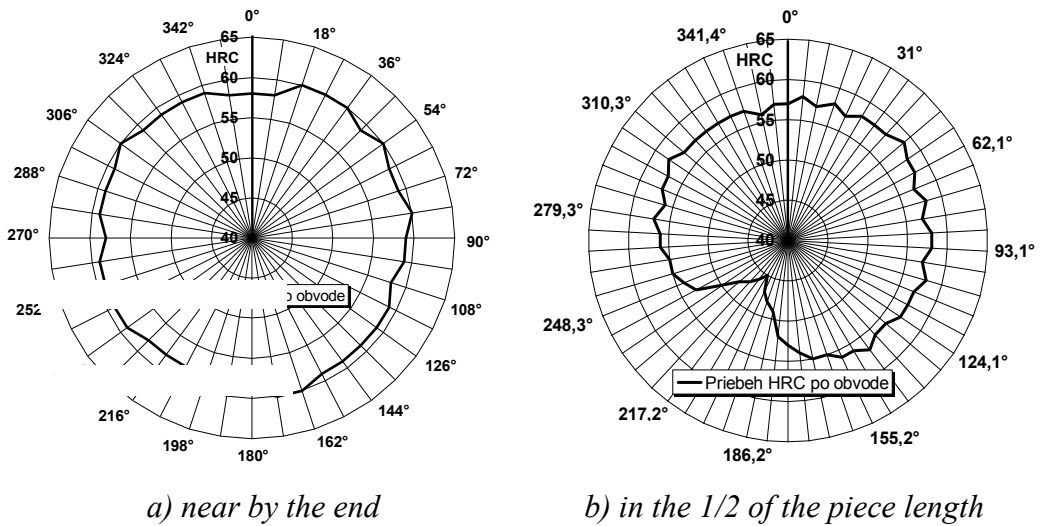
**Fig.3** Change of hardness in the different places of hardened pieces – bainite [3]

On the base of this analyse, there were carried out the next heat treatment to reach the uniform cooling of the whole workpiece. There was placed the sole workpiece into the salt and its length was only 125 mm. Analyse of the hardness show that there is no significant difference in the hardness on the periphery of the workpiece and hardness is similiar than that in the fig.3 a. The next, this hardness does not change from the point of view of the piece lenght (fig.4a).

There is the next negative effect, formation of the nose on the cutting edge when turning softer structure. Incorrect heat treatment causes that hardness in the middle part is lower than that near by the end not only in the place of the pieces contact (fig.3). The nose formation negatively affects surface roughness. On the other hand, there is no significant difference in the surface roughness when turning martensite and bainite structure. This situation illustrates fig.6.

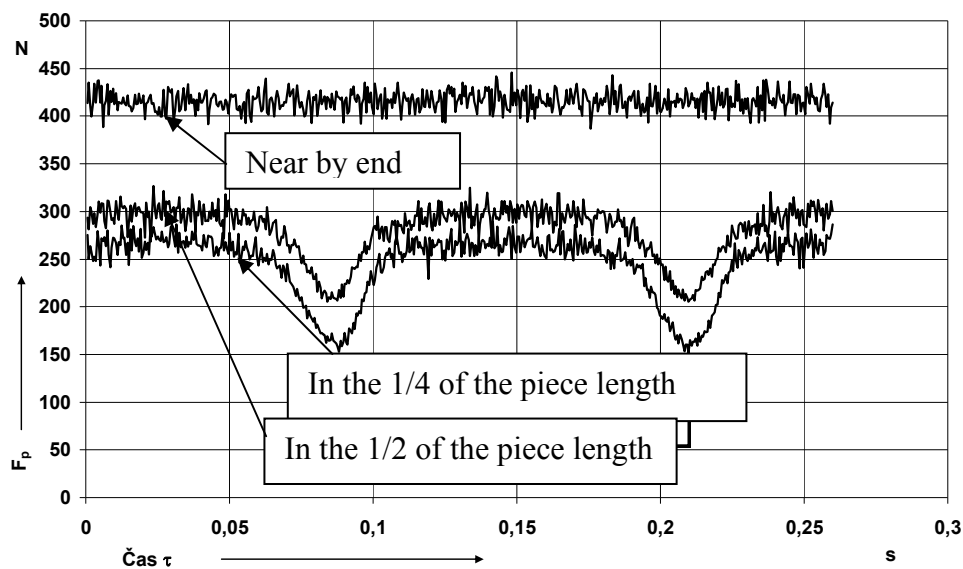
**Fig.5** Record of cutting force  $F_p$  in the different places of the piece length 250 mm after bainite heat treatment (there is offset 100 N of  $F_p$  record for near by end of the piece)

Measurement of cutting forces (measured by the dynamometer KISTLER) shows that incorrect heat treatment influences mechanical load of the tool. Detail analyze of records of cutting forces illustrated in fig.5 shows that hardness change leads to instability of mechanical load because cutting forces strongly depend on hardness of machined structure. There is a visible instability of cutting force  $F_p$  (on fig.5) in the place of the low hardness. Turning of profile without hardness change enable to have the relatively stable cutting process. This situation is illustrated by cutting force record near by end of the piece.

Instability of cutting force is unsuitable because leads to mechanical impacts on the tool. This dynamic character significantly affects tool wear considering the fracture toughness of ceramic tool. While durability of tool is about 57 minutes when turning bainite structure after correct heat treatment (cutting speed  $85 \text{ m}\cdot\text{min}^{-1}$ ), durability of tool is only 41 minutes when turning bainite structure after incorrect heat treatment (fig.8). Similar comparison was obtained for higher cutting speeds. There is more intensive tool wear when machining martensite structure of hardness 62 HRC in comparison with machining bainite structure after correct heat treatment.

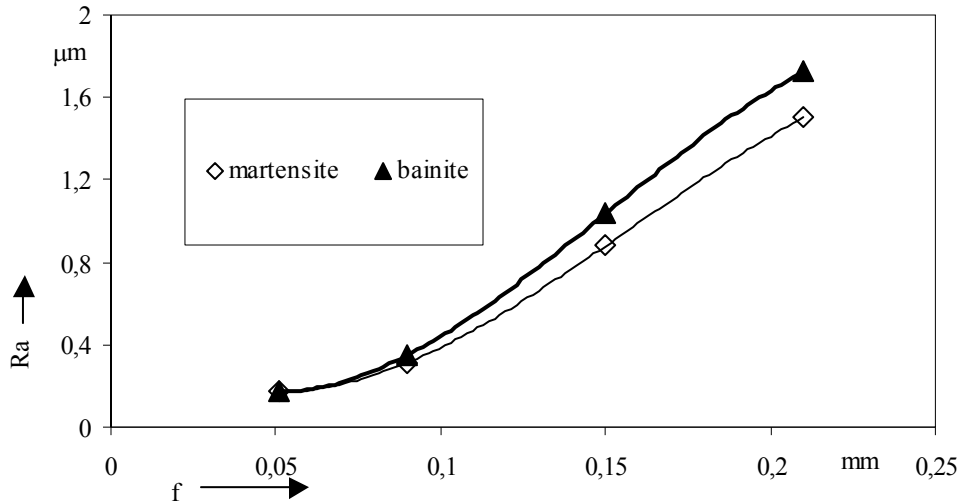
**Fig.6** Influence of feed  $f$  on roughness of machined surface  $Ra$

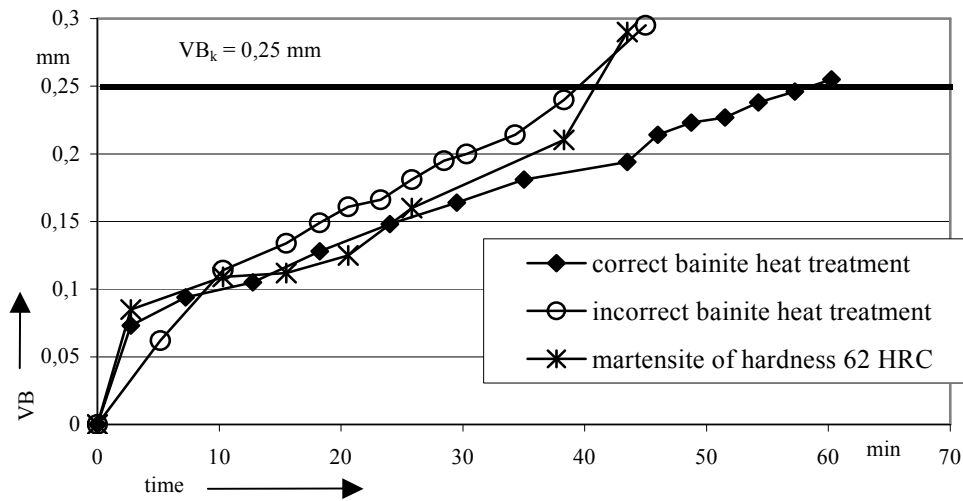
**Fig.8** Process of tool wear,  $a_p = 0,25 \text{ mm}$ ,  $f = 0,09 \text{ mm}$ ,  $v_c = 85 \text{ mm} \cdot \text{min}^{-1}$
